MEDICAL DEVICE CORRECTION: EnRhythm® Pacemakers.

IMPORTANT: MEDICAL DEVICE CORRECTION

EnRhythm® Pacemakers

February 2010

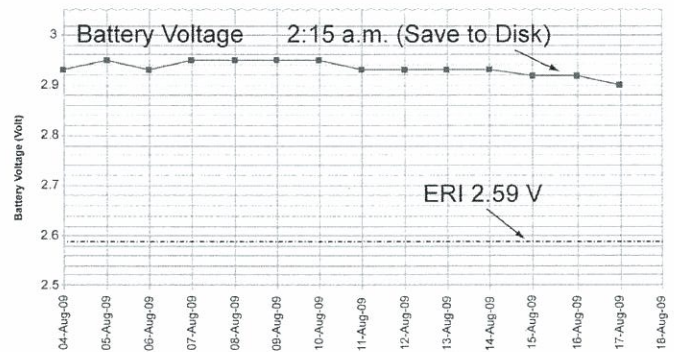
Medtronic has received 62 reports (out of approximately 110,000 devices worldwide) indicating that the battery voltage at device interrogation was lower than the battery voltage that is tracked by the device to provide data for the elective replacement indicator (ERI) notification. The lower voltage measurement has caused confusion and occasionally has resulted in unnecessary explants.

Medtronic's investigation has shown that none of these reports has resulted in loss of therapy. Importantly, the ERI notification, which uses the nightly battery measurement, is unaffected and accurate. Medtronic has identified the root cause as higher than expected battery resistance.

Example of nightly voltage trend above ERI – stored to device memory but not visible to user

Medtronic's internal testing has shown that there is no current risk for compromised therapy delivery. If the software update referenced above is not implemented, there will be a potential risk of loss of device functionality in a small percent (less than 0.08% six years post implant) of devices. The software update will eliminate this risk.

Medtronic recommends physicians continue to use the ERI notification to determine time for device replacement. At this time, no other action, reprogramming or change in the frequency of follow-up is recommended.
