IMPORTANT MEDICAL DEVICE CORRECTION:
Dual Chamber Models of Pacemakers: Kappa 600, 700, 800, 900, EnPulse, Adapta, Versa, Sensia <Relia, Vitatron Models E50A1, E60A1, and G70A1>

Performance Note

Dual Chamber Pacemakers with Measurement Lock-up ERI

Kappa 600, 700, 800, 900, EnPulse, Adapta, Versa, Sensia, Relia, and Vitatron Models E50A1, E60A1, and G70A1

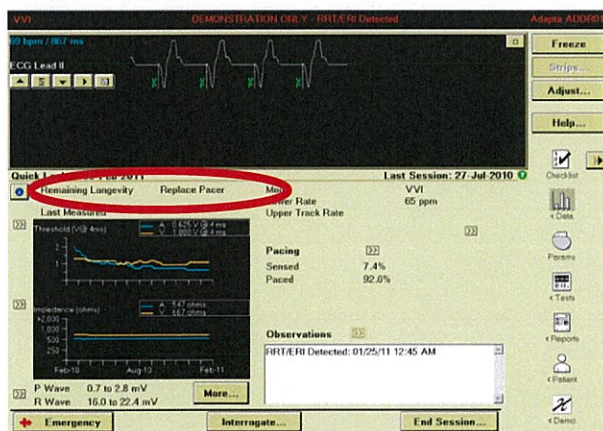
Example 1—Programmer Screen for Typical Pacemaker at ERI

Two examples of images from the Medtronic 2090 programmer are shown below. Example 1 shows what a normal ERI condition looks like. Example 2 shows what will be displayed if the ERI is triggered due to the measurement lock-up condition.

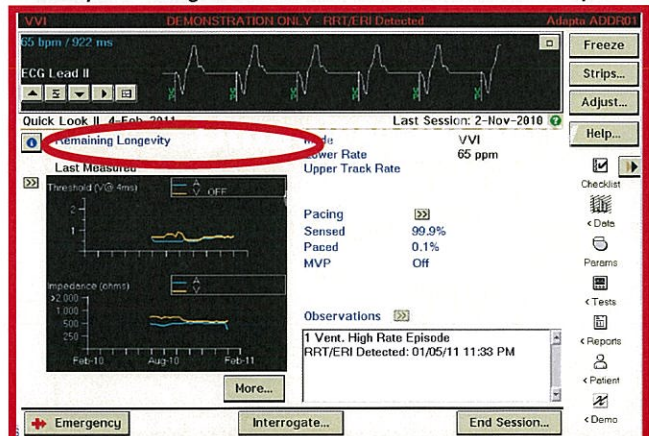
Example 2 – Programmer Screen for Measurement Lock-up ERI

A device that has experienced a measurement lock-up ERI will present ALL of the following symptoms:

- Device declaring ERI/RRT
- Remaining Longevity = <Blank> on the programmer (and CareLink where available)
- Battery Voltage = <Blank> on the programmer (and CareLink where available)
- If the user attempts to take a Battery and Lead Measurement, a pop up window will indicate that it cannot estimate remaining battery life.

This condition can be reset and does not require device explant. If this measurement lock-up occurs, obtain a save-to-disk file and contact Medtronic Brady Technical Services at 1-800-505-4636 for assistance. Reset devices are no more likely to experience a recurrence of this issue.
