Urgent Field Safety Notice

LASW21-02.A.AP2.OUS

Aptio Automation

Interface Module to the ADVIA® Centaur XP/XPT

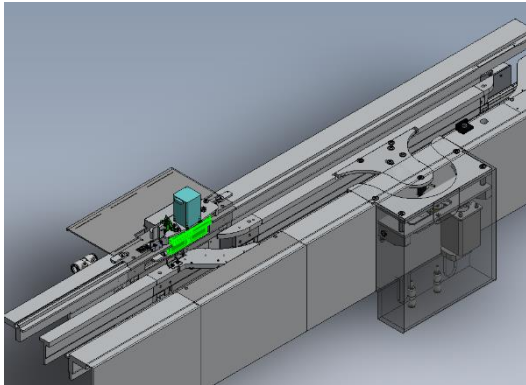
Image 1.a: ADVIA Centaur XP/XPT Interface Module
(Part number FLX-021-00, APT-021-00)

- there are no obstructions that prevent the correct activation and movement of the divert, refer to Image 1.a.
- the divert looks to be intact, refer to Image 2.a.
- the position of the diverter is aligned to the profiles when it is diverting a tube, refer to Image 3.a; tubes that need to be routed by the Analyzer are diverted fluidly, without any missing or partial block of the carrier.

If the visual check does not pass, contact your local technical support for assistance.
