Reference: 2024-009M

URGENT - FIELD SAFETY NOTICE

To user of **Olympus Thunderbeat Type S Hand Instruments**

Re: Olympus to Reinforce Existing Instructions and Warnings from IFU for Thunderbeat Type S Hand Instrument.

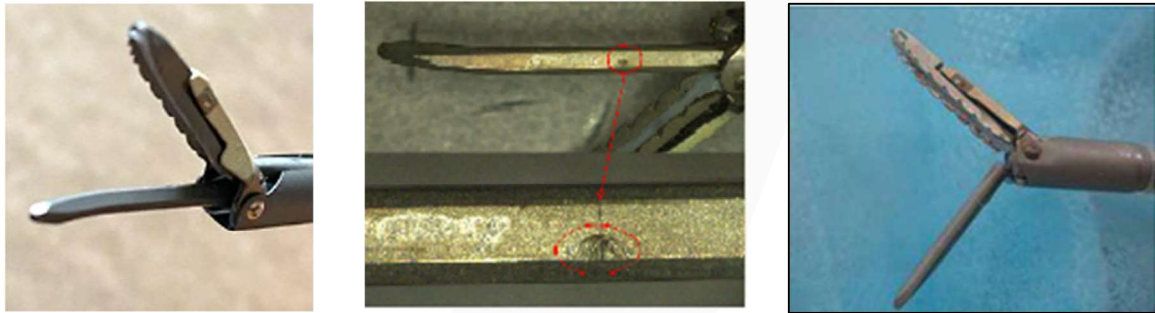
Olympus has been made aware, via customer feedback, of reports where probe tips of the THUNDERBEAT Type S Hand instrument are becoming damaged or are breaking (Reference example in Figure 1), as well as instances of pad damage or detachment (Reference example in Figure 2). These issues can occur when the instructions and warnings in the IFU are not followed, specifically, taking very large bites of tissue, contact with metal while activating, and activation without tissue between the jaws.

Figure 1. Example of Thunderbeat Probe in accordance with specifications (left), Cracked Probe (Center) and Probe Fracture (right)

A broken probe tip or damaged tissue pad may lead to patient harms of foreign body in the patient, requiring imaging and prolonged operative time or an additional procedure to locate and remove the broken piece. Additionally, tissue damage and bleeding could occur due to exposed sharp edges. A broken piece remaining in the patient could potentially lead to an inflammatory reaction or granuloma. The probe tip or tissue pad breaking due to high temperatures and falling into the patient, may cause thermal injury to the patient.

In addition, Olympus strongly recommends the use of the ITM (Intelligent Tissue Monitoring) function to prevent probe pad damage due to over-activation and therefore reduce the likelihood of probe tip damage. When using this function, the energy output automatically stops after the target tissue is divided. This is indicated by an audible signal/stop tone. Note: This function may need to be switched to 'on' on your generator, if not already enabled.

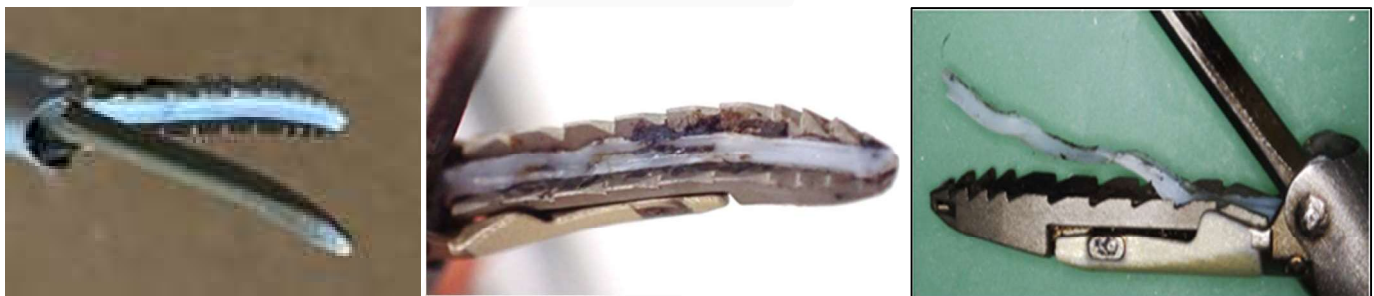
Figure 2. Example of Thunderbeat Probe in accordance with specifications (Left), Tissue Pad Deformation (Center), Tissue Pad Detachment (Right)
