Medical Device / Equipment ALERT: Field Corrective Action

Ref:MDB/A/2008/012

**FIELD CORRECTIVE ACTION - PROSTIVA[®] RF MODEL 8929 HAND PIECE
NEEDLE RETRACTION FAILURE.**

PROSTIVA® RF Model 8929 Hand Piece Needle Retraction Failure

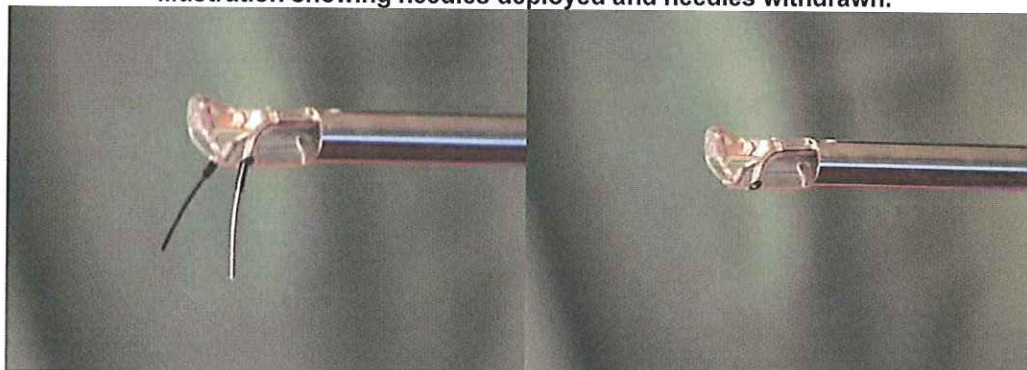
1. If the handle lever is broken (blue handle lever is loose), use the camera to verify that the needles are deployed. If the needles are not deployed, the Hand Piece can be removed normally.

It is critical to avoid movement of the metal urethra tube and the needles while attempting this disassembly procedure.

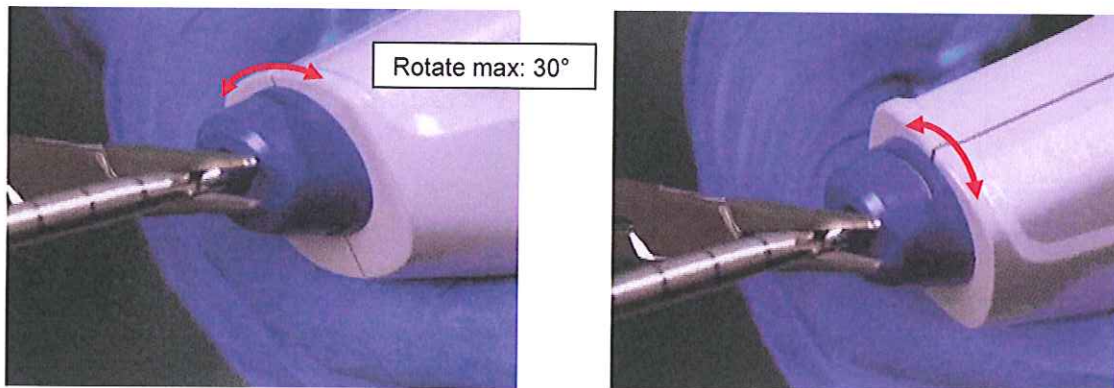
The plastic handle cannot fully rotate due to an alignment feature on the metal tube. Do not attempt to rotate beyond 30 degrees in either direction.

5. Next, **GENTLY** rotate the gray plastic hand piece from side to side around its longitudinal axis to break the adhesive joint. Do not rotate the plastic hand piece beyond 30 degrees in either direction.
