1 September 2010

URGENT FIELD SAFETY NOTICE

Affected devices: Thoratec HeartMate II[®] Left Ventricular Assist System (HM II LVAS) System Controllers

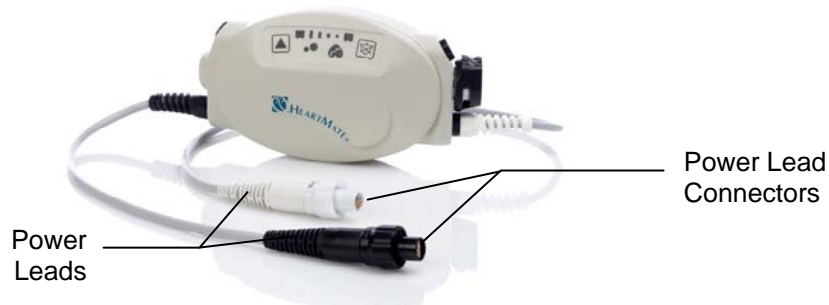
Description of problem: Thoratec has become aware of a recent trend in complaints related to the HM II System Controller. Bending fatigue has resulted in broken data communication wires in the power leads, and bent pins in the connectors between the System Controller and its power sources (batteries, Power Base Unit [PBU] or Power Module [PM]) have interfered with the connections to the System Controller power leads. Broken wires and bent connector pins have the potential to interrupt pump function.

Immediate action to be taken: You should contact all ongoing patients using the affected System Controllers (serial numbers starting with “EPC”) to determine if they are experiencing any unexplained intermittent alarms or have any bent pins in the connectors between the System Controller and the power sources. If so, you should request that they return to the hospital so that their power leads can be examined. If you need further assistance with this evaluation, please contact Thoratec Europe Ltd by phone at: +44 (0) 1480 455200.

Preventive action: Please review the attached addendum to the HeartMate II labeling with all VAD clinicians and ongoing HeartMate II LVAS patients. The information in the addendum is intended to prolong the useful life of the power leads. Additional instructions are also provided to prevent damage to the power lead connector pins when changing power sources.

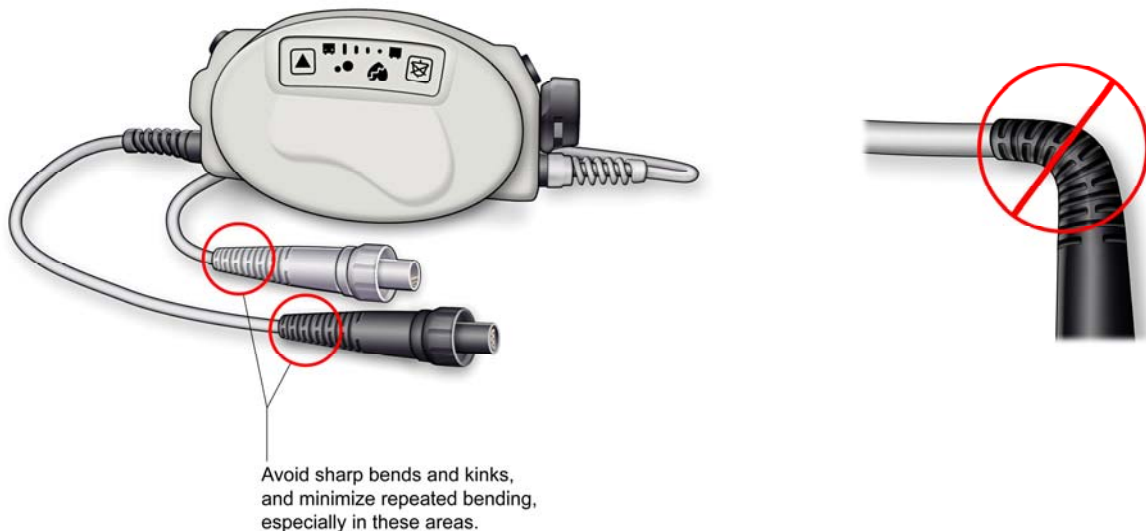
While your heart pump should allow you to return to many of your daily activities, it is extremely important to protect your power leads, especially if you are active. Always keep your power leads protected from sharp bends, kinking and repetitive bending. Damage to the power leads, depending on the degree, may cause the pump to stop.

- Do not severely bend your power leads, especially at the strain reliefs near the System Controller connectors.
- When transporting your System Controller, avoid placing it in bags or accessories that cause the power leads, especially near the connectors, to have sharp bends.
- If you carry your System Controller in a carrying case, don't "catch" the power leads in the zipper.
- Minimize repeated bending of the power leads, especially near the connectors.
- Do not let the power leads become twisted.
