URGENT FIELD SAFETY NOTICE
Notice of Potential Stent Expansion Uniformity Out of Specification Condition

Cordis CYPHER SELECT®+Sirolimus-eluting Coronary Stent
Catalog numbers CRB28XXX and CRB33XXX (see listing at end of letter)

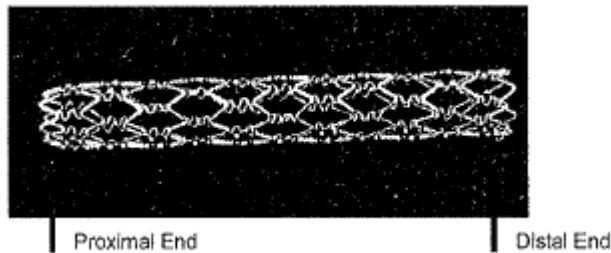
An example of a stent that does not meet SEU internal design criterion is shown below. This condition is related to alignment between the balloon, marker band and stent. For the affected devices, the proximal end of the stent may be positioned over the tapered section of the balloon. Note that the proximal end of the stent is not as dilated as the central region and distal end. Therefore, the difference between the stent diameter at the proximal end and the rest of the stent is $\geq 10\%$ in this example.

Cordis has performed a root cause investigation and has taken corrective actions. The investigation determined the cause for the Stent Expansion Uniformity (SEU) over 10% is due to the positioning of the stent outside of the balloon working length during manufacturing. Cordis has implemented a corrective action of adjusting the position of the stent on the balloon during assembly.

Patient harm is unlikely when using stents with this particular SEU condition, when the condition is recognized and treated appropriately. In the event a stent with the SEU condition is used in a patient, additional balloon dilatation (as directed in the CYPHER® instructions for use) is appropriate. Consistent with the IFU, it is common medical practice in interventional cardiology to assess the adequacy of stent deployment and in the majority of cases, to perform a second inflation with a non-compliant balloon at high pressure before this final assessment is completed. Given this standard practice of post-dilatation, it is unlikely the SEU condition would persist. Based on our investigation and data on experience in the field, the SEU condition has not been associated with a risk to patient safety.
