Urgent Medical Device Correction

Subject: Potential risk of probe tip overheating associated with Welch Allyn® Braun® ThermoScan® PRO 6000 Ear Thermometer.

FSCA-identifier: FA-2021-05-001-SKF-004

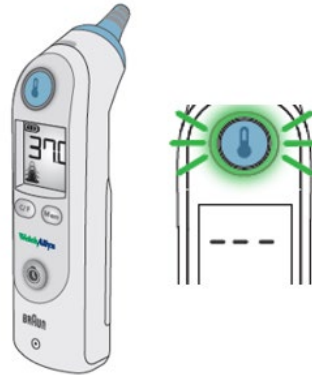
Figure 1

Our investigation has confirmed that the probe tip overheating is the result of fluid ingress. Fluid ingress causes the sensor to behave inconsistently, which does not allow the built-in safety mitigation (turn off the heating element) to work correctly. The majority of the devices which experience overheating of the probe tip show one of two behaviors at time of power up:

1. The ring around the measurement button will show a green blinking or flashing light instead of a ready state (solid green light).
2. The device requires multiple power-ups prior to going to ready state (solid green light). See Figure 1.

1. Please share this communication with all potential users in your organization and instruct them to follow the provided Cleaning Guide for proper cleaning.
2. Do not use the device if the ring around the measurement button shows a green blinking or flashing light instead of a “ready state” (solid green light) and contact Hillrom Customer Service to report this issue.
3. Do not use the device if the device requires multiple power-ups prior to going to “ready state” (solid green light) and contact Hillrom Customer Service to report this issue.
4. If you experience an overheating probe tip, do not use the device and contact Hillrom Customer Service to report the issue.
5. Complete the attached response form and return to hillromSKF004OUS@stericycle.com within one month.
