**URGENT Field Safety Notice**  
Zenition 50, Zenition 70, Veradius Unity systems

Wireless footswitch connection issues causing  
interruption of live Fluoroscopy imaging or exposure

29-Nov-2021

**Reference: 2021-IGT-PUN-011: Wireless footswitch connection issues causing interruption of live Fluoroscopy imaging or exposure**

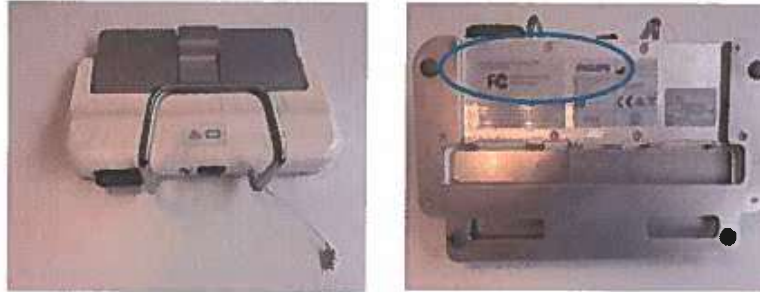
The model name and model number can be found on the label located on the bottom of the footswitch as shown in Figure 1.

Figure 1: Label location on the bottom of the footswitch
