**URGENT Field Safety Notice**

Azurion 7 M20 FlexArm system with Maquet Magnus Table  
Unavailable Motorized Table and/or FlexArm Movement Potentially Resulting in Delay or Termination  
of Procedure.

08-DEC-2023

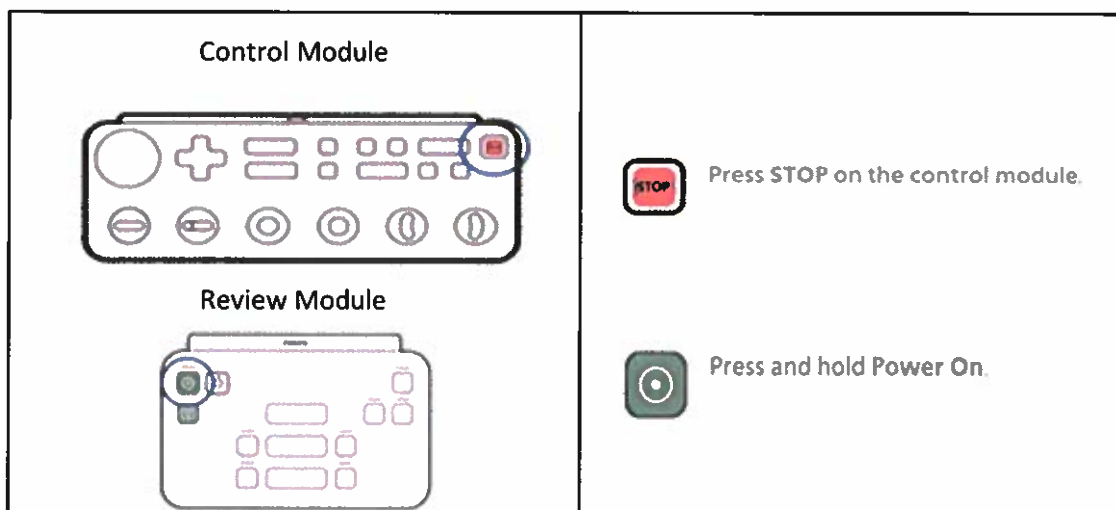
The connection between the FlexArm and the Table may not reestablish if the detector continues to be at approximately four (4) cm from the patient when the Table restarts. This will result in a recurring connection loss between the FlexArm and the Table, during which Table movement will be unavailable. In some cases, motorized movement of the FlexArm may also become unavailable, in which case the FlexArm will prompt user messages indicating a Table collision when the user requests motorized movement of the FlexArm.

- Until Philips implements the solution in your system. during the procedure:
  - a) Avoid positioning the detector at approximately four (4) cm from the patient.
  - b) If the Connection Issue occurs, perform the following actions **in sequential order**:
    1. move the detector so that it is no longer at approximately four (4) cm from the patient.
    2. if moving the detector doesn't resolve the issue, restart the geometry of the FlexArm as follows:
      - o Press 'STOP' on the **Control Module**
      - o Press and hold the 'Power On' button on the **Review Module**

After this, both Table movement and FlexArm motorized movement will become available again.
