Reference: 2025-009M

URGENT - FIELD SAFETY NOTICE

To all users of **Olympus ShockPulse Lithotripsy System and Transducer**

Re: Olympus to Provide Supplemental Guidance.

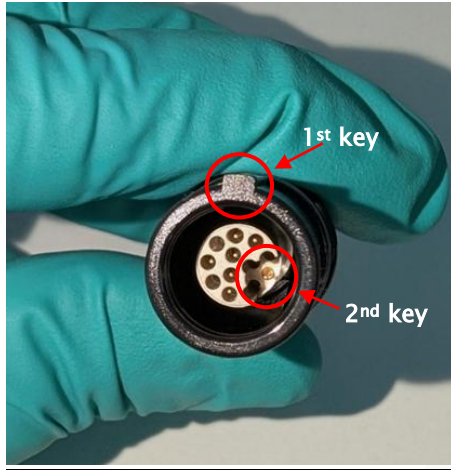
Transducer Plug Configuration:

- 7 pins
- Double-keyed
 - 1st key (“key way”): Square feature on top
 - 2nd key: Round recessed pin on bottom right

- Correct orientation of keying features (as shown in picture)
- No lint, debris, or moisture present
- Pins are straight (not bent)
- No cracks or physical damage

If damage to the transducer plug, including the pins, is identified, cease use of the damaged transducer and utilize the back-up transducer. Contact Olympus to initiate the return of your damaged device for complaint investigation.

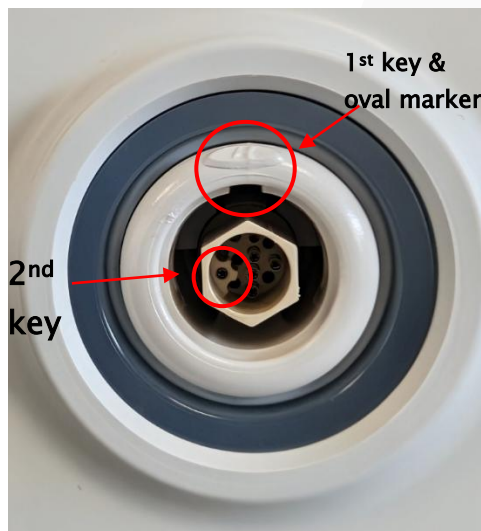
Generator Transducer receptacle Configuration:

- 7 pin terminals
- Double keyed:
 - 1st key (“key way slot”): Square feature centered at top. The white oval marker on the outer ring indicates the location of the square.
 - 2nd key: Round pedestal terminal on bottom left.

- Correct orientation of keying features (as shown in picture)
- No lint, debris, or moisture present
- Pin terminals are round (not bent)
- No cracks or physical damage

If damage to the generator transducer receptacle, including the pin terminals, is identified, cease use of the generator. Contact Olympus to initiate return of your generator for repair.

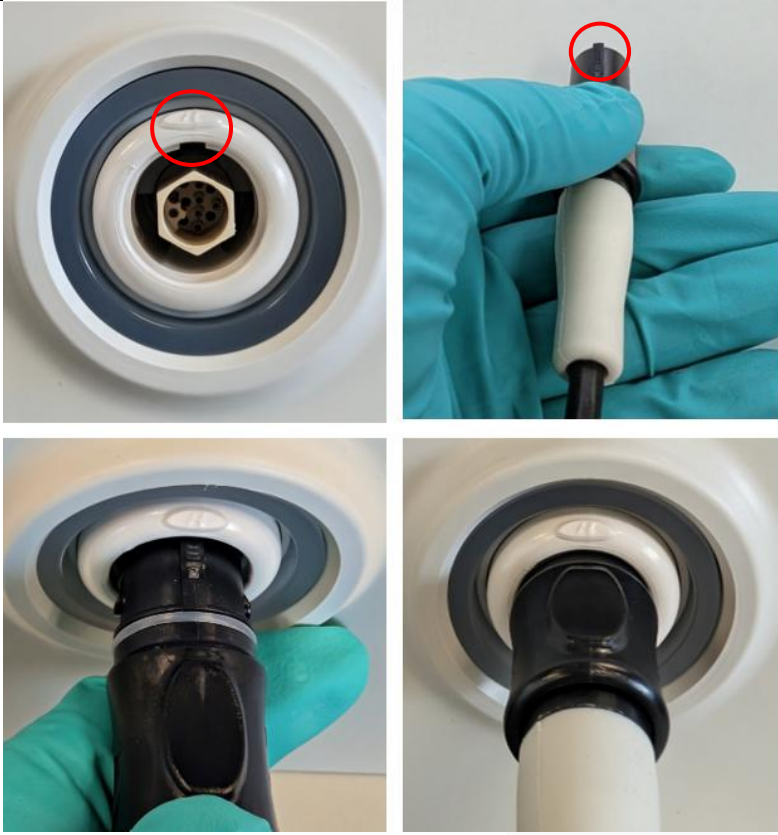
Steps to plug the Transducer into the Generator (per the “Assembling the Unit” section of the ShockPulse-SE Lithotripsy System (SPL-S, SPL-SR) IFU):

Connect the transducer to generator by aligning key way of the transducer connector with the key way slot on the transducer receptacle on the front panel. Push straight in. CAUTION: Do not twist or turn the plug.
