Template Rev 2: February 2020
CellaVision FSCA Ref: CA25-013
CellaVision FSN Ref: FSN-CV-2025-004-ROW

Date: 2025-10-10

Field Safety Notice
Automated Digital Cell Morphology Analyzer DI-60

Field Safety Notice (FSN)
Automated Digital Cell Morphology Analyzer DI-60
Barcode reader issue

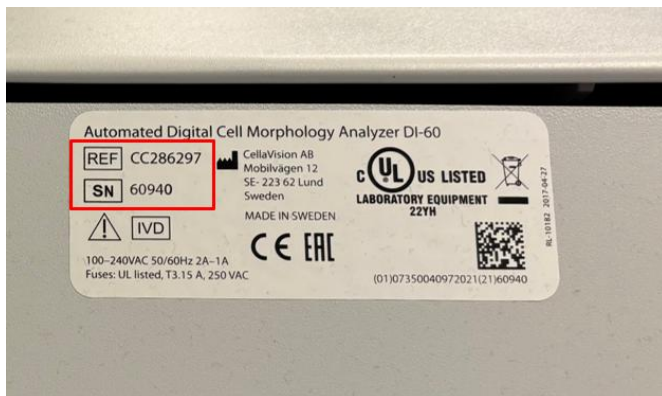
Figure 1. Example of label with REF and SN.

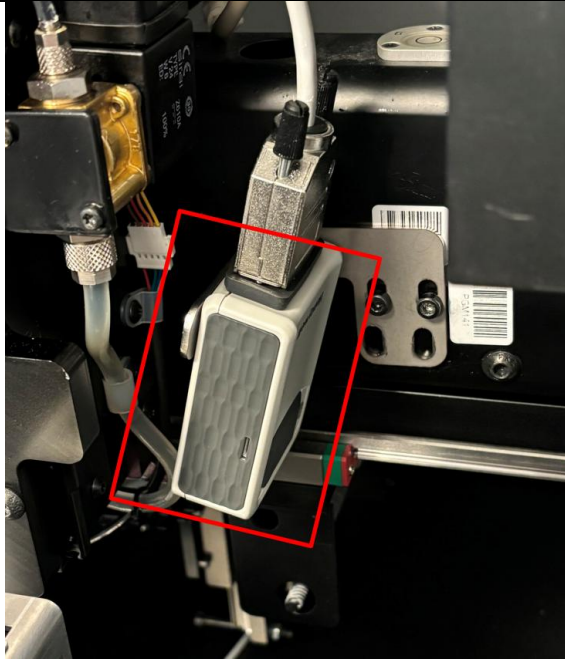
Figure 2. Image of the Honeywell Vuquest barcode reader installed in system.

<p>Action (FSCA) is being initiated to mitigate the risk and ensure continued patient safety.</p> <p>Internal investigation has confirmed that the malfunction is caused by conditions in the CCU firmware in combination with newer barcode readers (Honeywell Vuquest and JadaK FM-5).</p> <p>Specifically, the barcode reader has a field of view that is too large, allowing capture of the barcode on the return slide (located next to the fetch slide). The barcode reader continues to attempt barcode reading after the gripper has released the return slide, thereby exposing its barcode. To eliminate the root causes, corrective actions have been implemented in the CCU firmware (version 4.2.7), which includes:</p> <ul style="list-style-type: none">- Reducing the effective field of view of the barcode reader.- Preventing additional barcode reading attempts once the gripper has released the return slide. <p>Firmware version 4.2.7 has already been introduced in manufacturing. As part of this FSCA, all affected DI-60 instruments in the field will be updated with the corrected firmware via Distributor's service engineers. Distributors are required to confirm completion of the update.</p> <p>These actions are justified to prevent recurrence of the malfunction, to mitigate the risk of slide misidentification, and to ensure patient safety.</p>

3.	4. Action Being Taken by the Manufacturer	
	<input checked="" type="checkbox"/> On-site device modification/inspection <input checked="" type="checkbox"/> Software upgrade	
	<p>A new Firmware (version 4.2.7) has been developed to solve the problem associated with the barcode reader. This new version shall be installed in affected units through a Field Safety Corrective Action. The installation will be performed by Sysmex service personnel, who will contact affected users to schedule a time for firmware update. Refer to Technical Note TN-148 for information and details regarding the Field Safety Corrective Action.</p>	
3.	5. By when should the action be completed?	As soon as possible
3.	6. Is the FSN required to be communicated to the patient /lay user?	No
