Reference: 2025-X001M

URGENT: MEDICAL DEVICE REMOVAL

Product: OLYMPUS ViziShot 2 FLEX

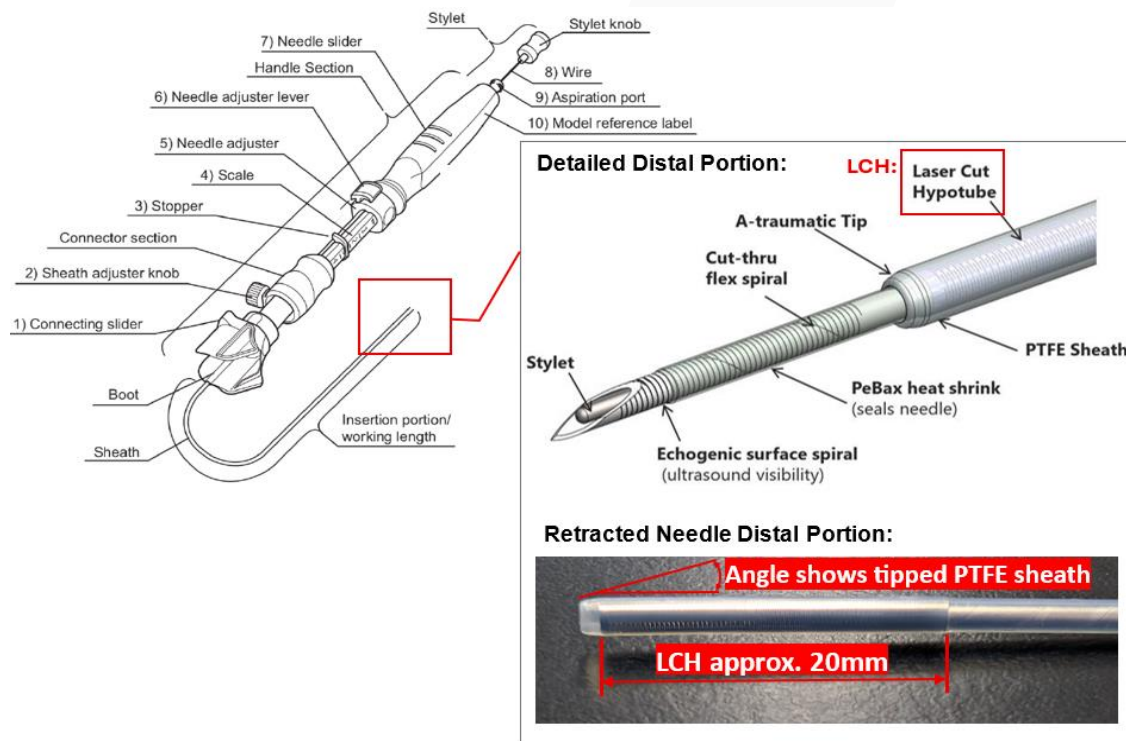
Figure 1: ViziShot 2 Flex Components

Olympus has received a total of 91 complaints for the ViziShot 2 FLEX (19G) device, where the laser cut hypotube component has ejected from the device, or plastic components have detached. See illustration for identification of the hypotube component. Of these complaints, 43 were reported to regulators as malfunctions, 40 were reported as serious injury (or potential for serious injury), and 1 was reported for potential contribution to a patient death, though a causal relationship could not be determined due to insufficient information received regarding the event. The laser cut hypotube protects the sheath from the needle tip and provides stability during transit and insertion. If device damage occurs, whether detected or undetected and the device continues to be used, the hypotube component has the potential to eject from the device. In addition, if the a-traumatic tip of the ViziShot 2 FLEX (19G) device is improperly formed at the time of manufacturing, and if this is undetected during manufacturing, it could potentially contribute to the likelihood of the hypotube ejecting from the device during use.
