Reference: 2025-X003M

17 December 2025

URGENT: MEDICAL DEVICE REMOVAL

Product: OLYMPUS Thunderbeat Hand Instruments

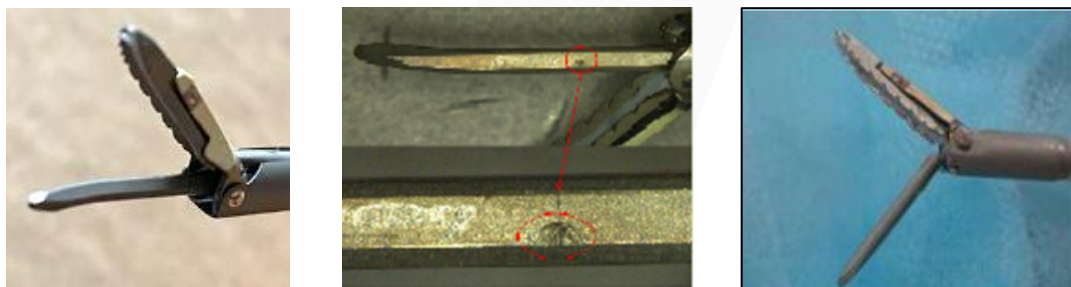
- **Probe tip damage or breakage** - Multiple instances where probe tips of THUNDERBEAT™ Type S hand instruments have become damaged or broken during use (reference example in Figure 1).
- **Tissue pad issues** - Reports of tissue pad damage or detachment from the instruments (reference example in Figure 2).

Olympus was made aware, via customer complaints, of reports where probe tips of THUNDERBEAT™ hand instruments are becoming damaged or are breaking (reference example in Figure 1), as well as instances of tissue pad damage or detachment (reference example in Figure 2). Investigations by Olympus demonstrated that these issues can occur when the instructions and warnings in the IFU are not followed, specifically, taking very large bites of tissue, contact with metal while activating, and activation without tissue between the jaws. However, due to a continuation of occurrences of this issue, Olympus is removing potentially affected models of THUNDERBEAT™ hand instruments from the market.

Figure 1. Example of THUNDERBEAT™ Probe in accordance with specifications (left), Cracked Probe (Center) and Probe Fracture (right)

A broken probe tip or a damaged tissue pad may lead to various patient harms. Of these harms, the most common harm is a foreign body in the patient due to a probe tip and/or tissue pad that becomes damaged and breaks off the device during use. When this occurs, this can also potentially result in a prolonged operative time, the requirement to perform imaging examinations, or an additional surgical procedure to locate and remove the broken device fragment. In rare circumstances, tissue damage could occur due to exposed sharp edges on the device when the probe tip breaks or becomes damaged. Additionally, bleeding may occur if the tissue pad fails or probe breaks, causing an inadequate seal. Post-operative bleeding events could, in rare circumstances, result in life-threatening injuries. Olympus has received one complaint of a postoperative death due to hemorrhage; however, the device was not returned to Olympus for further evaluation and there was insufficient information

1. Examine your inventory for affected THUNDERBEAT™ hand instrument models as listed on page 1 of this FSN.
2. ***Immediately cease use of all affected devices and quarantine the products.***
3. Olympus will contact you to arrange for return of your device to Olympus, and we will issue a credit to your facility.
4. Olympus requests that you acknowledge receipt of this letter. Indicate on the Response Form that you have received and understood this notification by filling out and returning the completed enclosed Response Form to us.
5. Please forward this notice immediately to other users who may have the THUNDERBEAT™ devices if you have further distributed it.

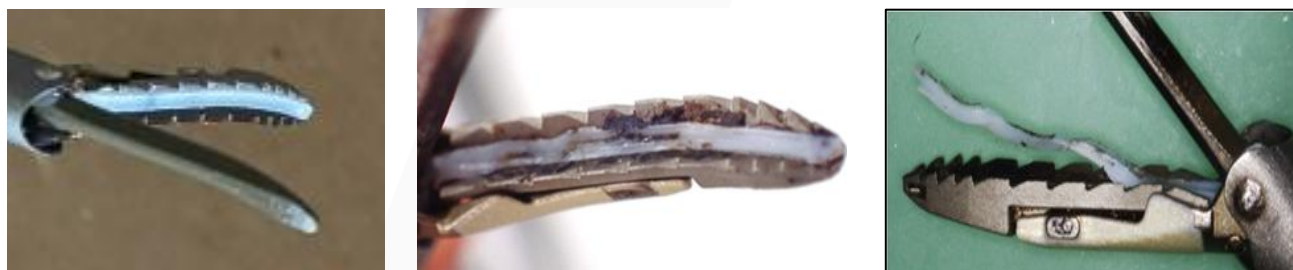
Figure 2. Example of THUNDERBEAT™ Probe in accordance with specifications (Left), Tissue Pad Deformation (Center), Tissue Pad Detachment (Right)
