IMPORTANT MEDICAL DEVICE CORRECTION:
Dual Chamber Models of Pacemakers: Kappa 600, 700, 800, 900, EnPulse, Adapta, Versa, Sensia <Relia, Vitatron Models E50A1, E60A1, and G70A1>

Performance Note

Dual Chamber Pacemakers with Measurement Lock-up ERI

Kappa 600, 700, 800, 900, EnPulse, Adapta, Versa, Sensia, Relia, and Vitatron Models E50A1, E60A1, and G70A1

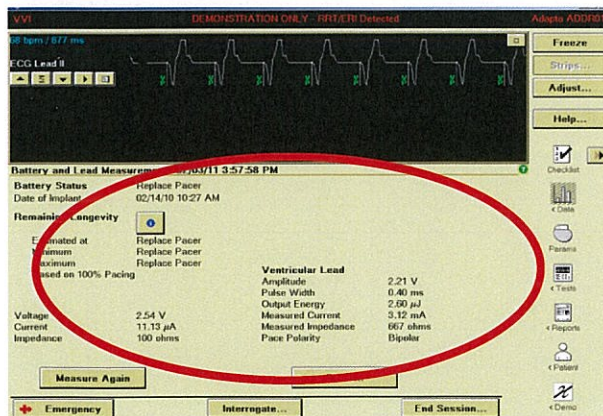
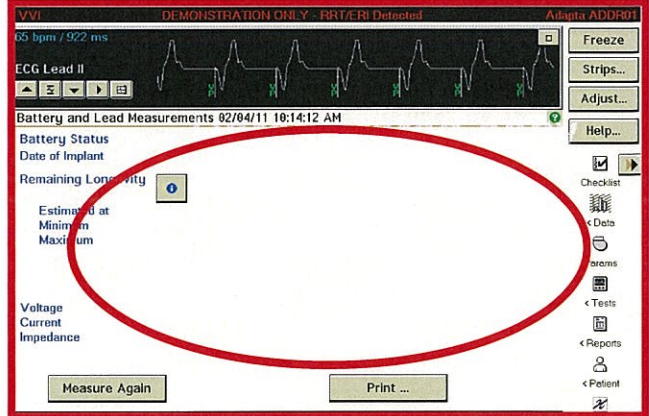
Example 2 – Programmer Screen for Measurement Lock-up ERI

Two examples of images from the Medtronic 2090 programmer are shown below. Example 1 shows what a normal ERI condition looks like. Example 2 shows what will be displayed if the ERI is triggered due to the measurement lock-up condition.

A device that has experienced a measurement lock-up ERI will present ALL of the following symptoms:

- Device declaring ERI/RRT
- Remaining Longevity = <Blank> on the programmer (and CareLink where available)
- Battery Voltage = <Blank> on the programmer (and CareLink where available)
- If the user attempts to take a Battery and Lead Measurement, a pop up window will indicate that it cannot estimate remaining battery life.

This condition can be reset and does not require device explant. If this measurement lock-up occurs, obtain a save-to-disk file and contact Medtronic Brady Technical Services at 1-800-505-4636 for assistance. Reset devices are no more likely to experience a recurrence of this issue.
