Reference: 2025-009M

URGENT - FIELD SAFETY NOTICE

To all users of **Olympus ShockPulse Lithotripsy System and Transducer**

Re: Olympus to Provide Supplemental Guidance.

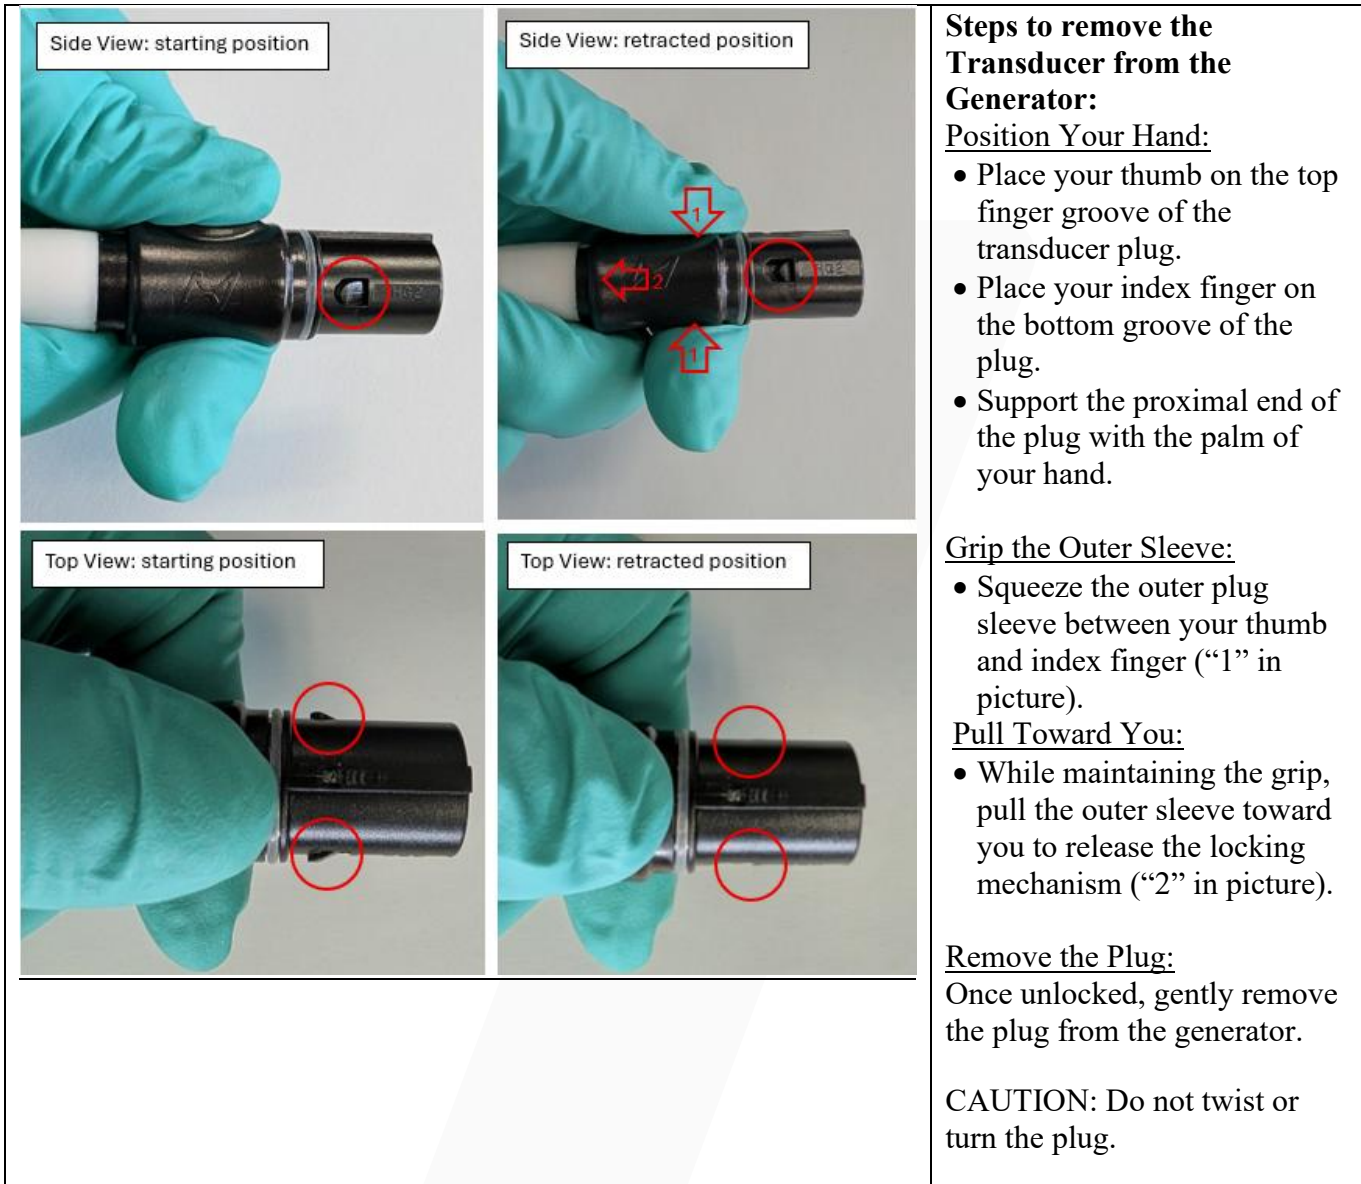
Connect the transducer to generator by aligning key way of the transducer connector with the key way slot on the transducer receptacle on the front panel. Push straight in. CAUTION: Do not twist or turn the plug.

CAUTION: Do not twist or turn the transducer or footswitch plugs when connecting them to the generator; equipment damage may result.

If damage to the transducer plug, including the pins, is identified, cease use of the damaged transducer and utilize the back-up transducer. Contact Olympus to initiate the return of your damaged device for complaint investigation.

If damage to the generator transducer receptacle, including the pin terminals, is identified, cease use of the generator. Contact Olympus to initiate return of your generator for repair.
