URGENT MEDICAL DEVICE NOTIFICATION

Medtronic Cobalt™ and Crome™ Implantable Cardioverter Defibrillators (ICDs)
and Cardiac Resynchronization Therapy Defibrillators (CRT-Ds)

Software Update Available to Correct Potential for SmartSync Telemetry Error

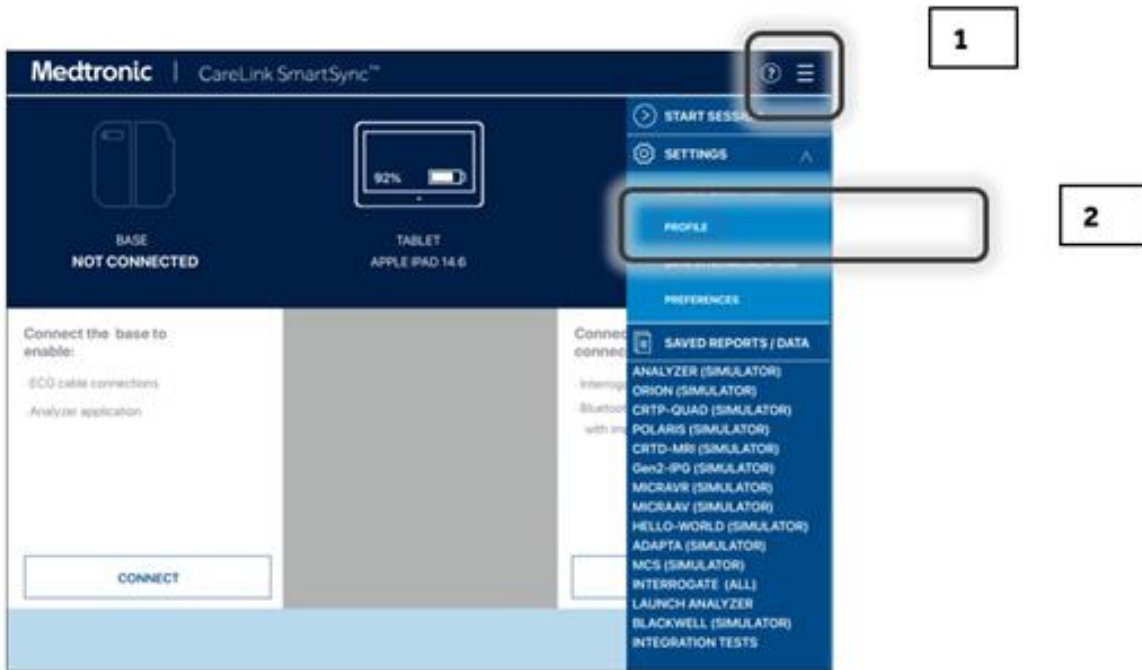
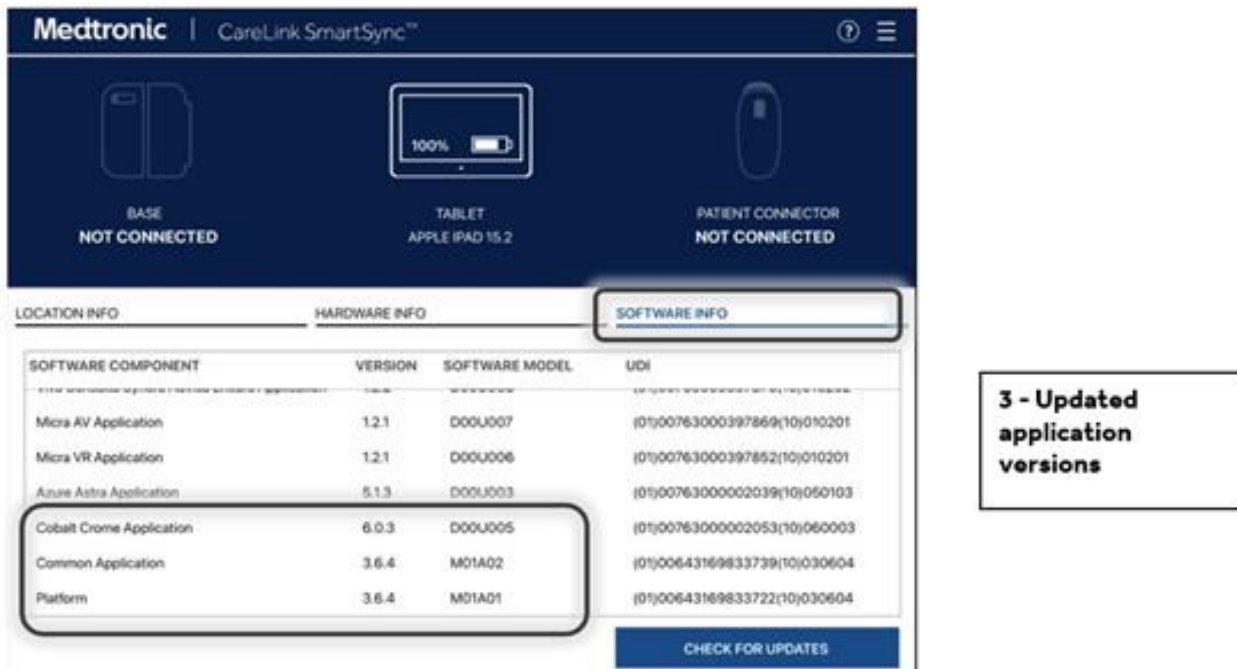
On any tablet, you can confirm the application software version for any device family by:

- 1) Selecting the MENU in the upper right corner of the SmartSync App [1]
- 2) Selecting PROFILE [2]
- 3) Selecting the SOFTWARE tab and scrolling through the SOFTWARE INFO list [3]

If the software update for this issue has already been installed, you will see the following versions listed:

- The Common/Platform application version is 3.6.4 (or higher)
- The Cobalt/Crome application version is 6.0.3 (or higher)
