## **URGENT Field Safety Notice**

Spectral CT with software version 5.0.X  
Plan Box not Updated during Interventional procedure and Incorrect Patient ID issues

November 8, 2024

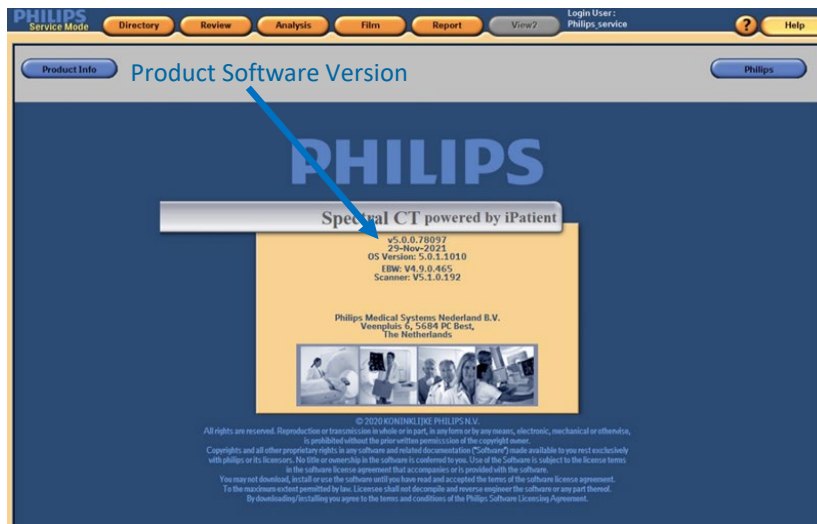
Figure 3. Spectral CT Software version shown as an example

1. Navigate to the Home screen and click the **Help** button.
2. Select **About** and the software version is then displayed as shown in Figure 3. The software version begins with v.
